FINAL WATER INTRUSION ASSESSMENT AND ASBESTOS SURVEY

DSH METROPOLITAN SNF BLDG REPAIR PROJECT

DEPARTMENT OF STATE HOSPITALS

May 2022

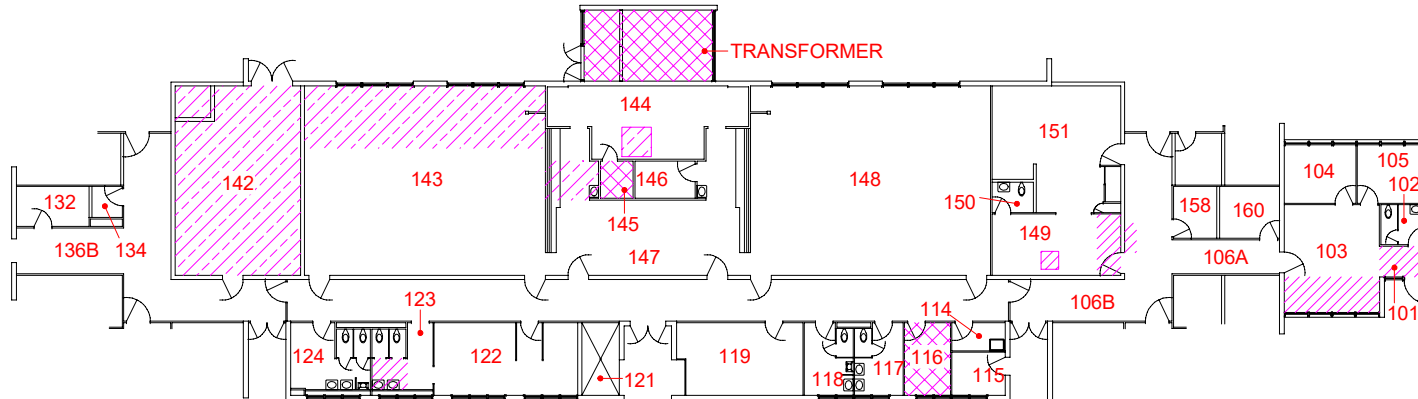
WATER DAMAGED MATERIALS/COMPONENTS
SNF BUILDING
UNIT A - CEILING PLAN
11401 BLOOMFIELD AVENUE
NORWALK, CALIFORNIA

Plaster ceiling with bubbling paint	Unit A: ceiling above sinks in Room 123. See Figure 1.	30	Yes	No	Remove bubbling paint. Dry plaster ceiling.
Drywall ceiling	Unit A: around vent cover on south portion of Room 144. See Figure 1.	4	Yes	No	Remove drywall ceiling with excessive moisture.
Plaster ceiling with 1'x1' ceiling tiles (water-stained)	Unit A: two locations in Room 149. One location is on the east portion of room and second location is on the south portion of room. See Figure 1.	50	Yes	Yes	Remove ceiling tiles. Dry plaster ceiling.
Plaster ceiling with 1'x1' ceiling tiles (water-stained)	Unit A: hallway outside east wall of Room 149. See Figure 1.	10	Yes	Yes	Remove ceiling tiles. Dry plaster ceiling.
Plaster ceiling with 1'x1' ceiling tiles (water-stained)	Unit A: Room 101 and south portion of Room 103 above carpeted area. See Figure 1.	140	Yes	Yes	Remove ceiling tiles. Dry plaster ceiling.

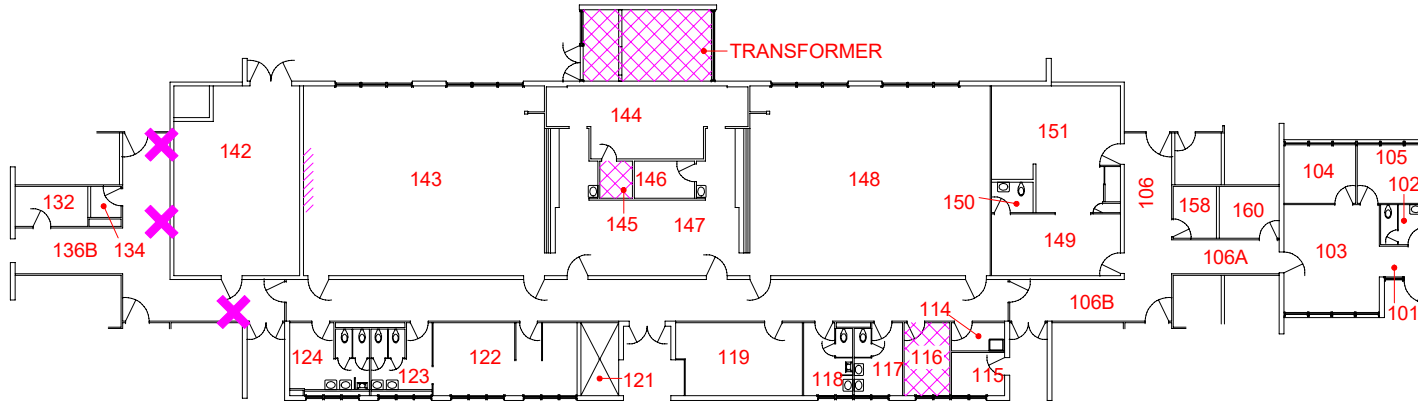
WATER DAMAGED MATERIALS/COMPONENTS
SNF BUILDING
UNIT A - WALL PLAN
11401 BLOOMFIELD AVENUE
NORWALK, CALIFORNIA

MATERIAL/COMPONENT	LOCATION	WATER DAMAGE (SF)	EXCESSIVE MOISTURE	MOLD PRESENT	RECOMMENDATION
Plaster wall with bubbling paint	Unit A: two locations on east wall in hallway west of mechanical equipment room (Room 142). See Figure 2.	12	Yes	No	Remove bubbling paint. Dry plaster wall.
Plaster wall with bubbling paint	Unit A: one location on south wall in hallway south of mechanical equipment room (Room 142). See Figure 2.	6	Yes	No	Remove bubbling paint. Dry plaster wall.
Plaster ceiling	Unit A: mechanical equipment room (Room 142). See Figure 1.	700	Yes	No	Remove plaster ceiling.
Plaster ceiling with bubbling paint	Unit A: north portion of Room 143. See Figure 1.	430	Yes	No	Remove plaster ceiling.
Drywall ceiling	Unit A: west portion of Room 147 (outside Room 145). See Figure 1.	60	Yes	No	Remove drywall ceiling with excessive moisture.
Plaster wall with bubbling paint	Unit A: west wall in Room 143. See Figure 2.	110	Yes	No	Remove bubbling paint. Dry plaster wall.

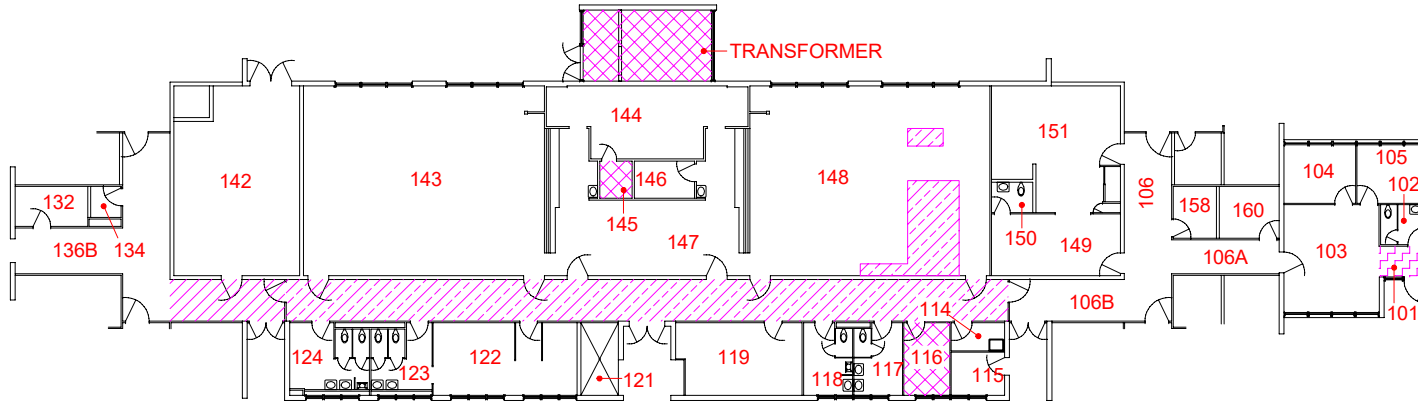
WATER DAMAGED MATERIALS/COMPONENTS
SNF BUILDING
UNIT A - FLOOR PLAN
11401 BLOOMFIELD AVENUE
NORWALK, CALIFORNIA

MATERIAL/COMPONENT	LOCATION	WATER DAMAGE (SF)	EXCESSIVE MOISTURE	MOLD PRESENT	RECOMMENDATION
Lifting floor tiles, 1'x1', brown with dark brown specks	Unit A: hallway south of mechanical equipment room (Room 142). See Figure 3.	140	Not Applicable	No	Remove all floor tiles and black mastic in hallway south of mechanical room (Room 142). The black mastic contains >1% asbestos.
Lifting floor tiles, 1'x1', light gray with gray and white specks	Unit A: hallway outside Rooms 143, 147, and 148. See Figure 3.	860	Not Applicable	No	Remove all floor tiles and black mastic in hallway outside Rooms 143, 147, and 148. The floor tiles and black mastic contain >1% asbestos.
Lifting floor tiles, 1'x1', tan with brown streaks	Unit A: two locations in Room 148. One location is on the north portion of room and second location is on the south portion of room. See Figure 3.	200	Not Applicable	No	Remove lifting floor tiles and black mastic in two locations in Room 148. The floor tiles and black mastic contain >1% asbestos.

Blue carpet	Unit A: Room 101. See Figure 3.	45	Yes	No	Dry and clean carpet.
Water-stained 1'x1' ceiling tile	Unit 417: east portion of Room 156. See Figure 4.	1	No	No	Remove water-stained ceiling tile.
Drywall ceiling with 1'x1' ceiling tiles	Unit 417: one location on east portion of hallway outside Room 142. See Figure 4.	10	Yes	No	Remove drywall ceiling and ceiling tiles with excessive moisture.
Drywall ceiling with 1'x1' ceiling tiles	Unit 417: around vent cover on southeast portion of Room 152. See Figure 4.	4	Yes	Yes	Remove drywall ceiling and ceiling tiles with excessive moisture.
Plaster wall with bubbling paint	Unit 417: east wall of hallway outside Room 141. See Figure 5.	4	Yes	No	Remove bubbling paint. Dry plaster wall.
Drywall ceiling with 1'x1' ceiling tiles (water-stained)	Unit 417: north portion of hallway starting outside Rooms 140 and 153. Two layers of drywall are present in the hallway and included in the water damage quantity. See Figure 4.	3,700	Yes	Yes	Remove drywall ceiling and ceiling tiles with excessive moisture.

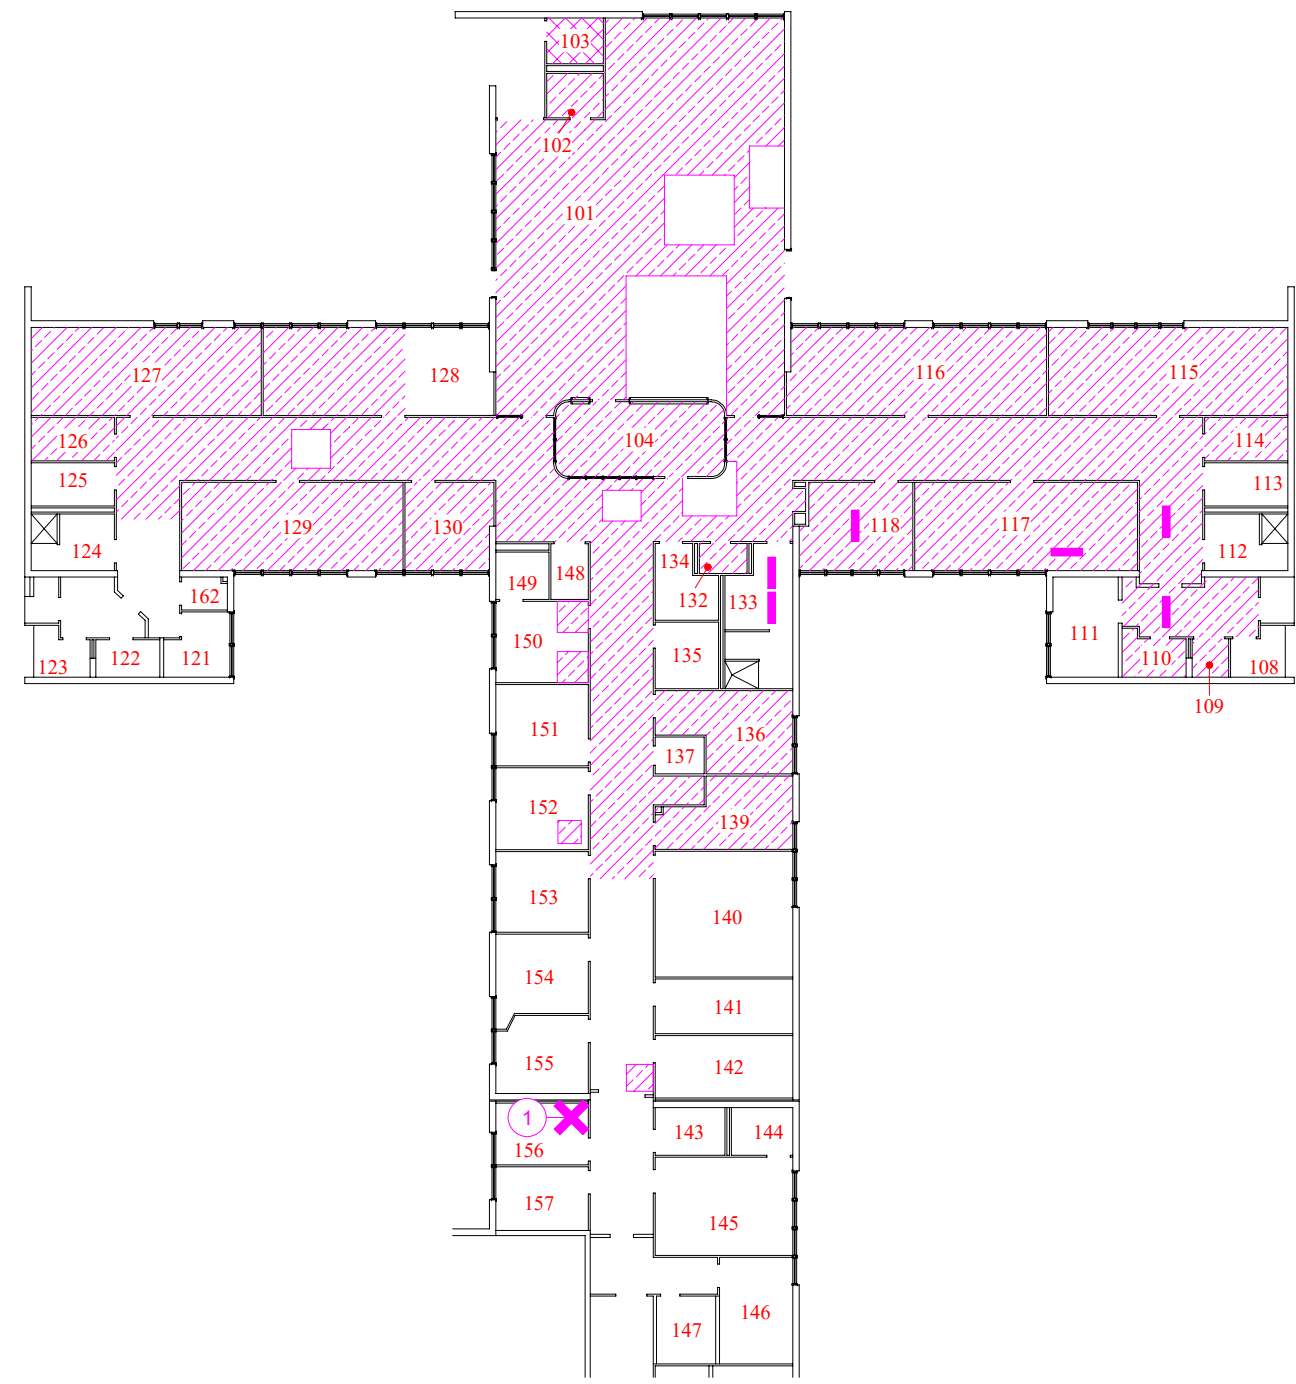
WATER DAMAGED MATERIALS/COMPONENTS
 SNF BUILDING
 UNIT 417 - CEILING PLAN
 11401 BLOOMFIELD AVENUE
 NORWALK, CALIFORNIA

MATERIAL/COMPONENT	LOCATION	WATER DAMAGE (SF)	EXCESSIVE MOISTURE	MOLD PRESENT	RECOMMENDATION
Drywall ceiling with 1'x1' ceiling tiles (water-stained)	Unit 417: Rooms 109, 110, 114, 115, 116, 117, 118, 126, 127, 129, 130, 132, 136, 139 and west portion of Room 128. See Figure 4.	2,800	Yes	Yes	Remove drywall ceilings in all rooms listed. Remove the drywall ceiling on the west portion of Room 128.
Drywall ceiling with 1'x1' ceiling tiles	Unit 417: two locations on the east portion of Room 150. See Figure 4.	40	Yes	Yes	Remove drywall ceiling and ceiling tiles with excessive moisture.
Plaster ceiling with 1'x1' ceiling tiles	Unit 417: Room 104. 50% of the ceiling has 1'x1' ceiling tiles remaining. See Figure 4.	210	Yes	No	Remove plaster ceiling.
Plaster ceiling	Unit 417: Room 102. See Figure 4.	40	Yes	No	Remove plaster ceiling.
Plaster ceiling with 1'x1' ceiling tiles	Unit 417: Room 101. The ceiling was removed in three locations. See Figure 4.	1,400	Yes	Yes	Remove plaster ceiling.

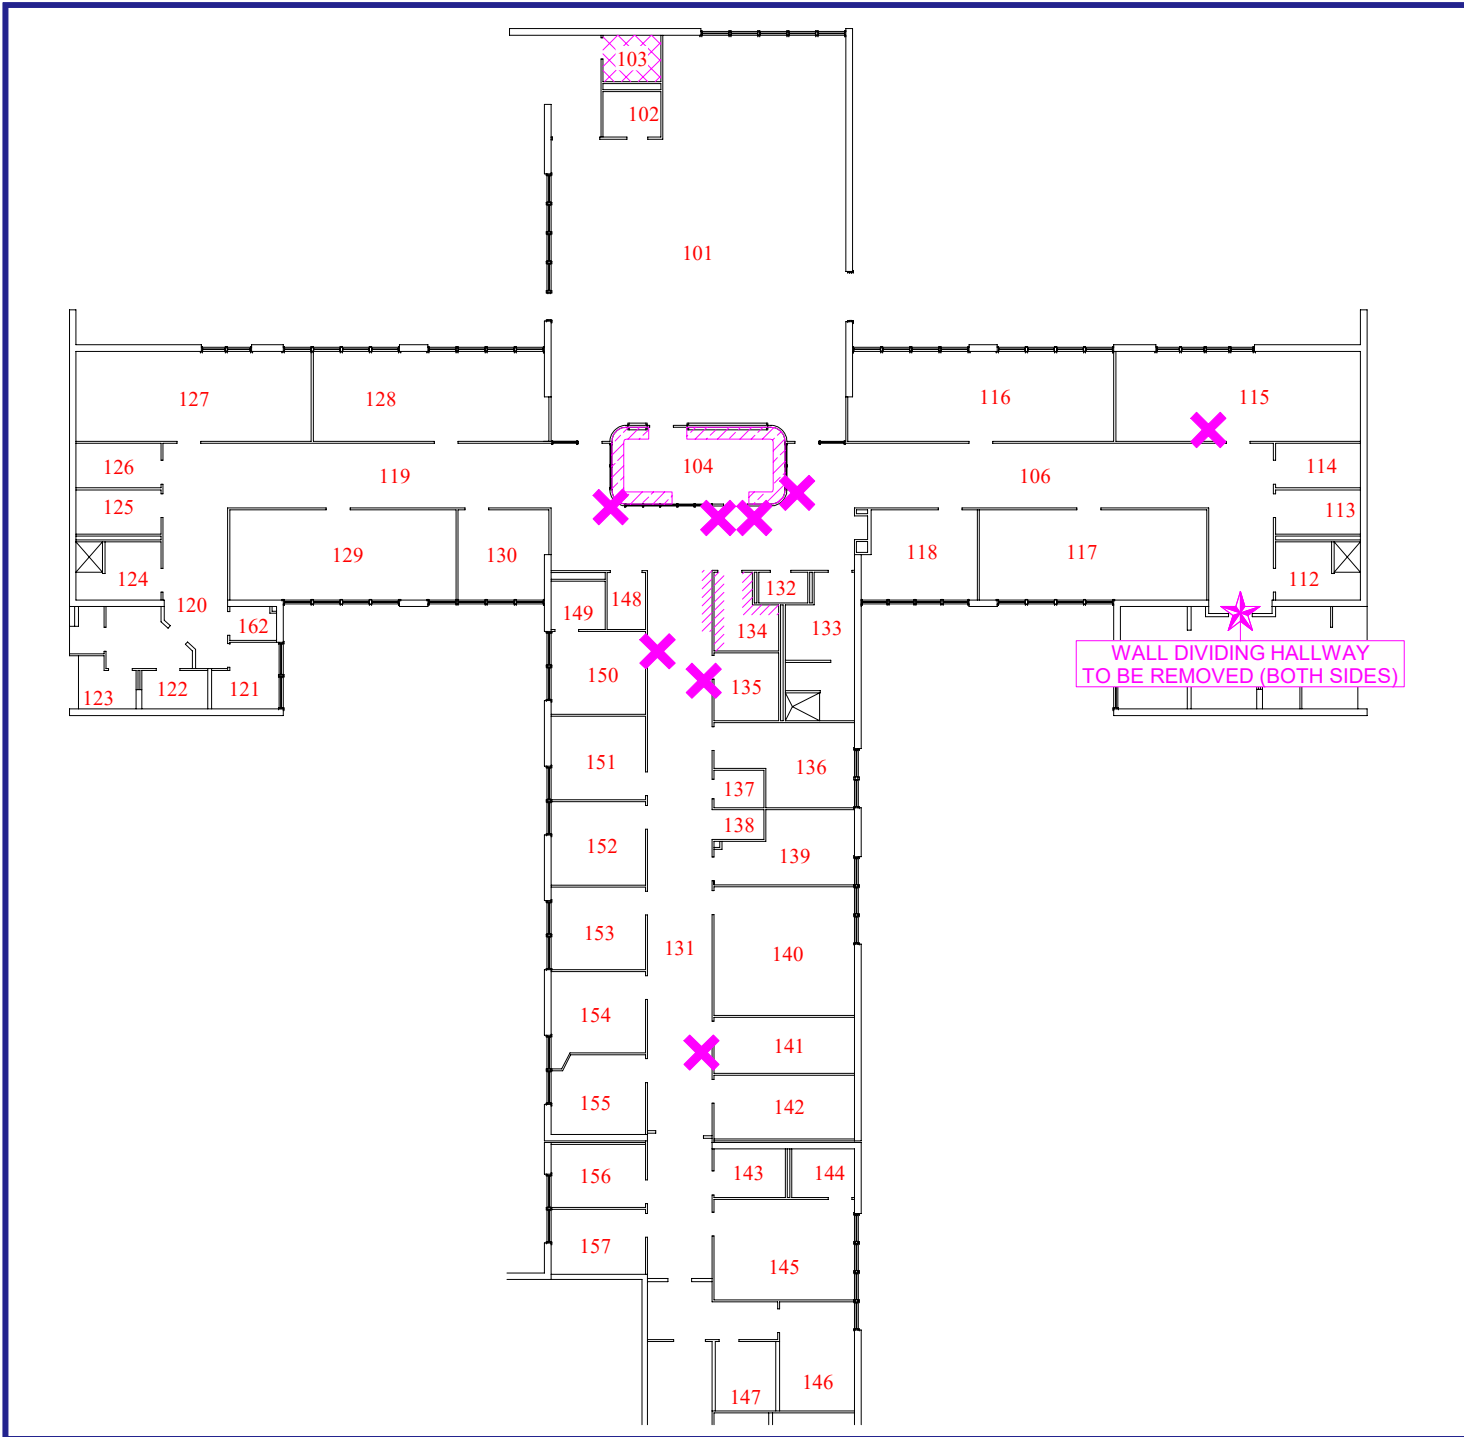
WATER DAMAGED MATERIALS/COMPONENTS
 SNF BUILDING
 UNIT 417 - WALL PLAN
 11401 BLOOMFIELD AVENUE
 NORWALK, CALIFORNIA

MATERIAL/COMPONENT	LOCATION	WATER DAMAGE (SF)	EXCESSIVE MOISTURE	MOLD PRESENT	RECOMMENDATION
Fiberboard wall with joint compound	Unit 417: wall dividing hallway into two (2) sections, outside Room 112. See Figure 5.	140	Yes	No	Remove fiberboard on both sides of wall dividing hallway.
Light fixtures filled with water	Unit 417: Room 133. See Figure 4.	2 fixtures	Not Applicable	No	Drain water and dispose of light fixtures.
Light fixture filled with water	Unit 417: Room 118. See Figure 4.	1 fixture	Not Applicable	No	Drain water and dispose of light fixture.
Light fixture filled with water	Unit 417: east portion of Room 117. See Figure 4.	1 fixture	Not Applicable	No	Drain water and dispose of light fixture.
Light fixtures filled with water	Unit 417: hallway outside Rooms 110 and 112. See Figure 4.	2 fixtures	Not Applicable	No	Drain water and dispose of light fixtures.
Lifting floor tiles, 1'x1', brown with dark brown specks	Unit 417: Room 136. See Figure 6.	160	Not Applicable	No	Remove all floor tiles and black mastic. The black mastic contains >1% asbestos.

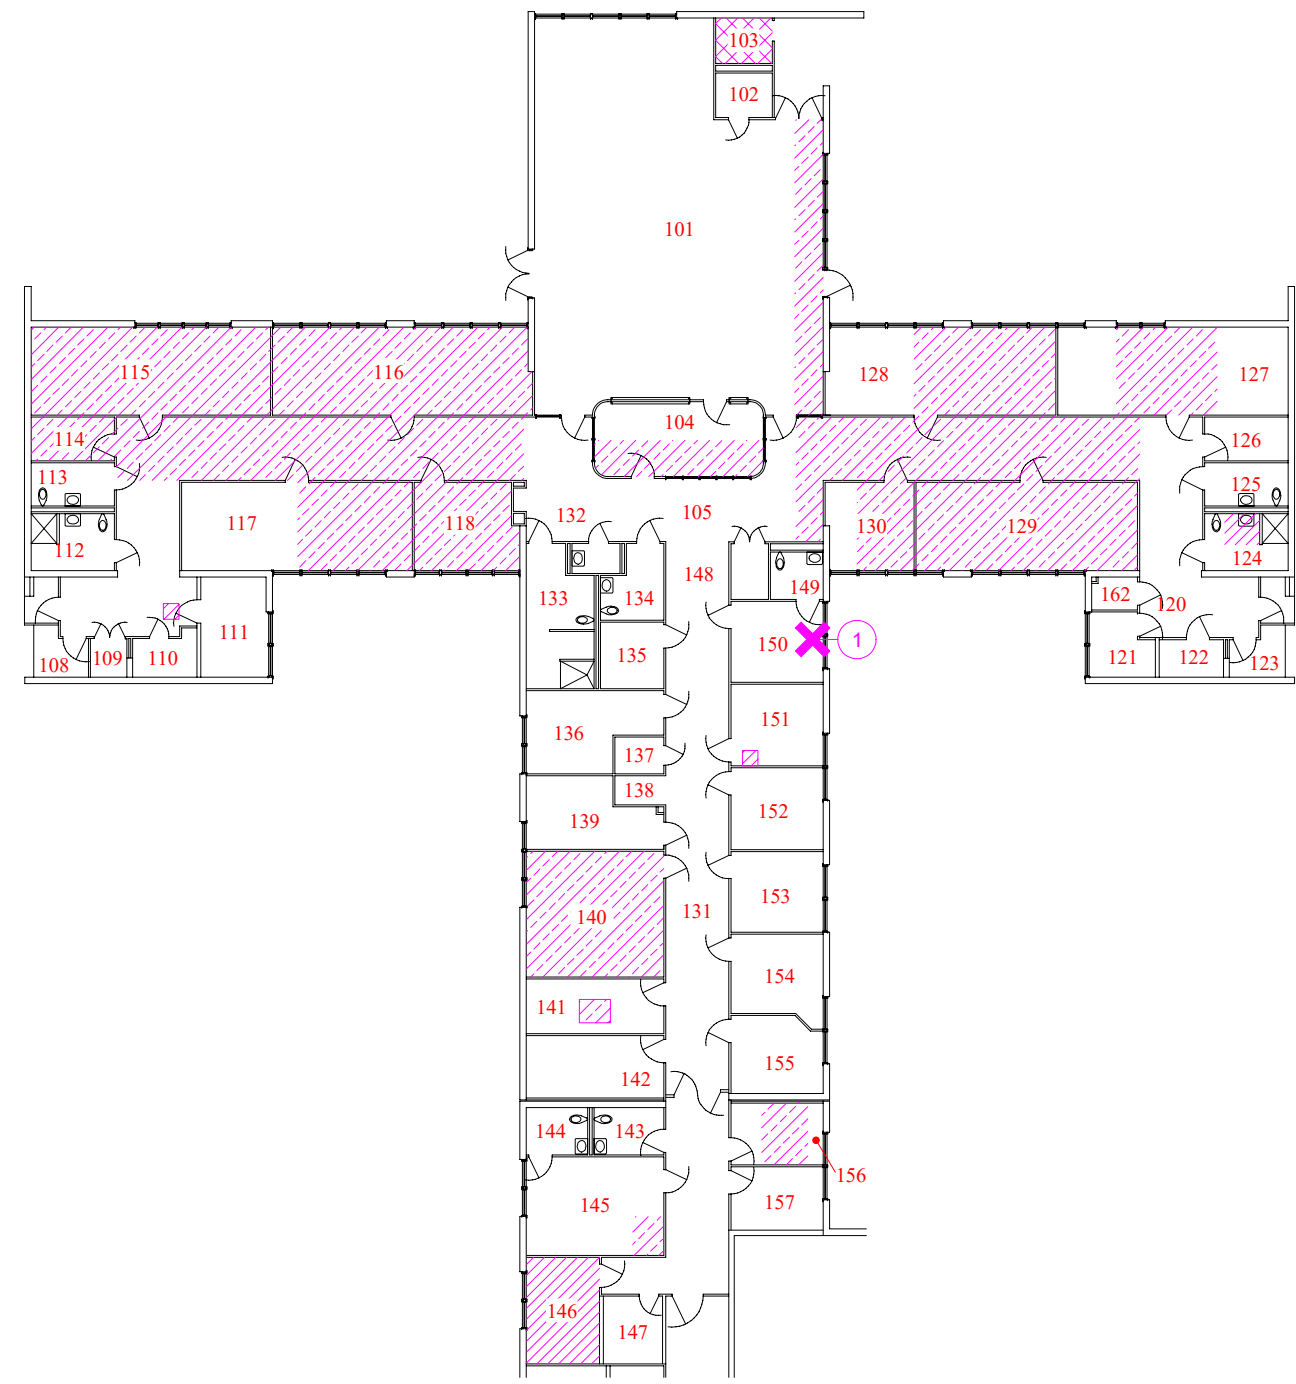
WATER DAMAGED MATERIALS/COMPONENTS
 SNF BUILDING
 UNIT 418 - CEILING PLAN
 11401 BLOOMFIELD AVENUE
 NORWALK, CALIFORNIA

Drywall ceiling with 1'x1' ceiling tiles	Unit 418: one location on the central portion of Room 141. See Figure 7.	12	Yes	Yes	Remove drywall ceiling and ceiling tiles with excessive moisture.

MATERIAL/COMPONENT	LOCATION	WATER DAMAGE (SF)	EXCESSIVE MOISTURE	MOLD PRESENT	RECOMMENDATION
Drywall ceiling with 1'x1' ceiling tiles (water-stained)	Unit 418: Room 140. See Figure 7.	300	Yes	Yes	Remove drywall ceiling.
Drywall ceiling with 1'x1' ceiling tiles	Unit 418: Room 156. See Figure 7.	50	Yes	Yes	Remove drywall ceiling.
Drywall ceiling with 1'x1' ceiling tile (water-stained)	Unit 418: one location on the southwest portion of Room 151. See Figure 7.	1	Yes	No	Remove ceiling tile. Dry ceiling.
Water-stained 1'x1' ceiling tile	Unit 418: east portion of Room 150. See Figure 7.	1	No	No	Remove water-stained ceiling tile.
Plaster ceiling	Unit 418: south portion of Room 104. See Figure 7.	100	Yes	No	Remove plaster ceiling.
Drywall ceiling with 1'x1' ceiling tiles (water-stained)	Unit 418: Rooms 114, 115, 116, 118, east portion of Room 117, and hallway outside these rooms. Two layers of drywall are present in the hallway and included in the water damage quantity. See Figure 7.	2,000	Yes	No	Remove drywall ceilings in Rooms 114, 115, 116, and 118. Remove a portion of the drywall ceilings in Room 117 and hallway.

Drywall ceiling with 1'x1' ceiling tiles (water-stained)	Unit 418: hallway outside Room 111. See Figure 7.	2	Yes	No	Remove ceiling tiles. Dry ceiling.
Plaster ceiling with 1'x1' ceiling tiles (water-stained)	Unit 418: east portion of Room 101. See Figure 7.	140	Yes	Yes	Remove plaster ceiling along entire east wall in Room 101.
Drywall ceiling with 1'x1' ceiling tiles (water-stained)	Unit 418: east portion of Room 128. Excessive moisture in the drywall ceiling start at the door and continues to the east wall. See Figure 7.	200	Yes	No	Remove drywall ceiling and ceiling tiles with excessive moisture.
Drywall ceiling with 1'x1' ceiling tiles (water-stained)	Unit 418: east portion of Room 130. Excessive moisture in the drywall ceiling starts at the end of first window and continues to the east wall. See Figure 7.	90	Yes	Yes	Remove drywall ceiling and ceiling tiles with excessive moisture.
Drywall ceiling with 1'x1' ceiling tiles (water-stained)	Unit 418: Room 129. See Figure 7.	330	Yes	No	Remove drywall ceiling.

MATERIAL/COMPONENT	LOCATION	WATER DAMAGE (SF)	EXCESSIVE MOISTURE	MOLD PRESENT	RECOMMENDATION
Drywall ceiling with 1'x1' ceiling tiles (water-stained)	Unit 418: central portion of Room 127. Excessive moisture in the drywall ceiling starts at the second window from the west wall and continues east for thirteen (13) feet. See Figure 7.	150	Yes	Yes	Remove drywall ceiling and ceiling tiles with excessive moisture.
Plaster ceiling	Unit 418: above sink on the north portion of Room 124. See Figure 7.	20	Yes	No	Dry plaster ceiling.
Countertop with cabinets	Unit 418: east wall in Room 104. See Figure 8.	40	Yes	No	Remove countertop and cabinets.
Drywall ceiling with 1'x1' ceiling tiles (water-stained)	Unit 418: a portion of hallway between Rooms 128 and 129. Two layers of drywall are present in the hallway and were included in the water damage quantity. See Figure 7.	800	Yes	No	Remove drywall ceiling and ceiling tiles with excessive moisture.

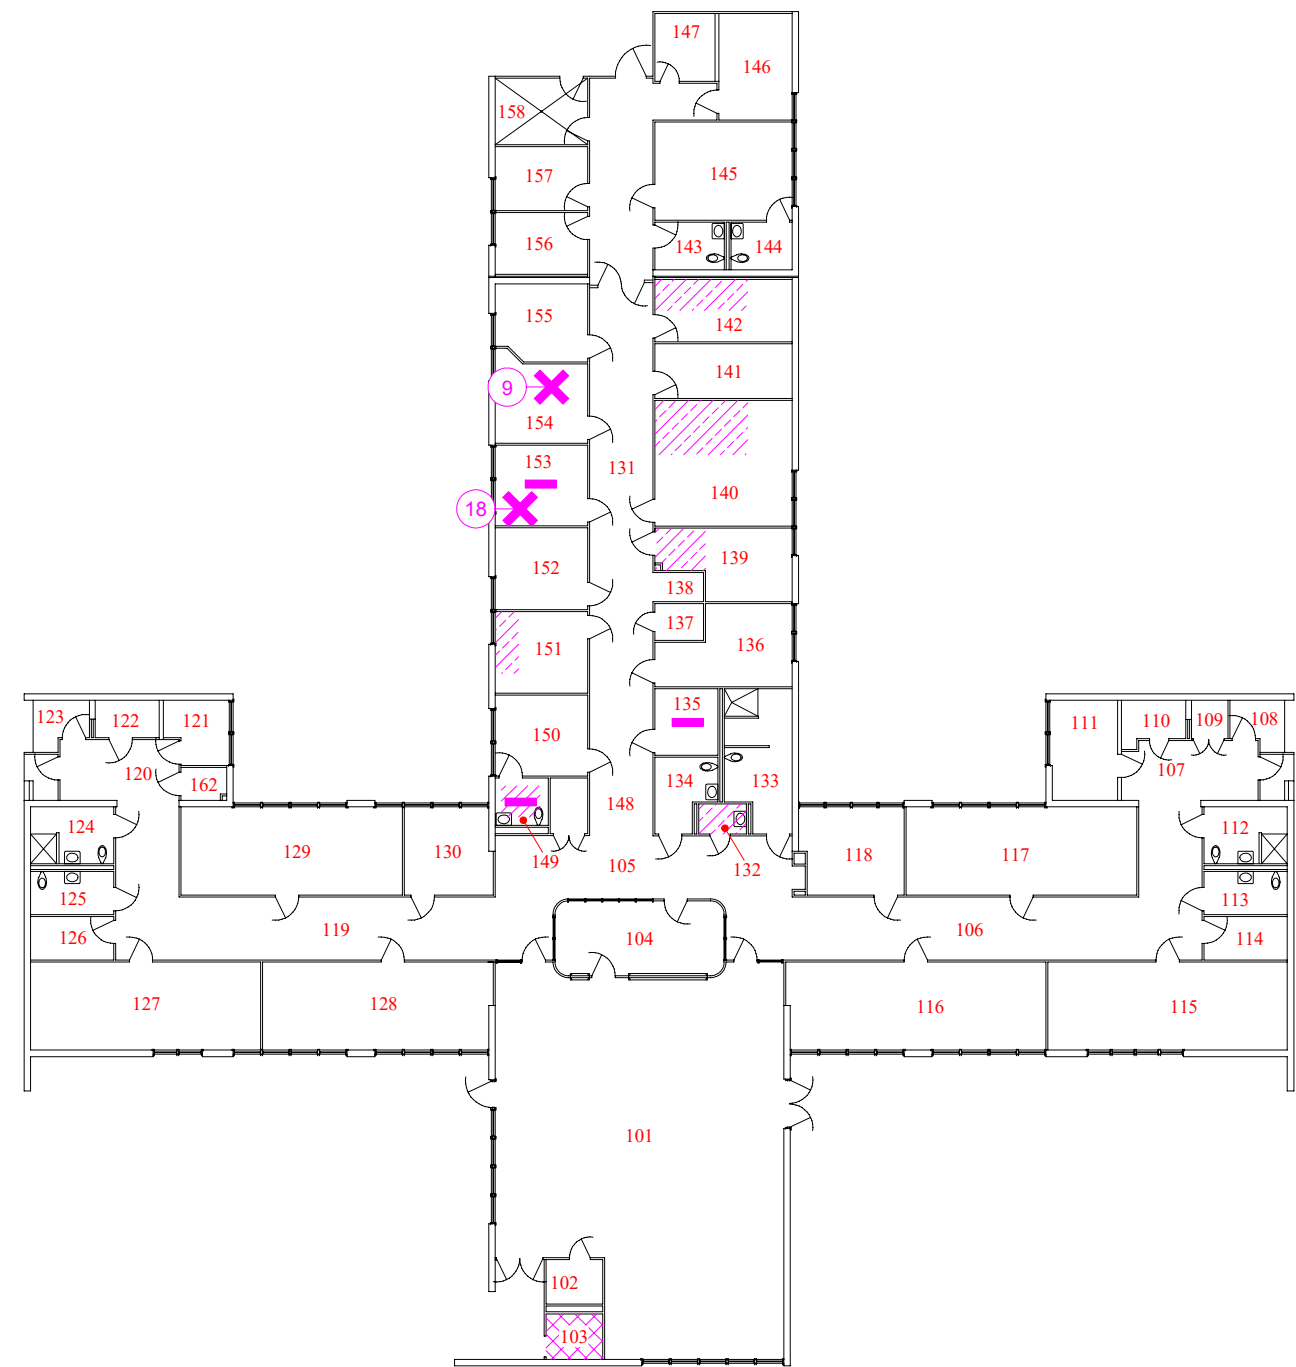
WATER DAMAGED MATERIALS/COMPONENTS
 SNF BUILDING
 UNIT 419 - CEILING PLAN
 11401 BLOOMFIELD AVENUE
 NORWALK, CALIFORNIA

MATERIAL/COMPONENT	LOCATION	WATER DAMAGE (SF)	EXCESSIVE MOISTURE	MOLD PRESENT	RECOMMENDATION
Drywall ceiling with 1'x1' ceiling tiles	Unit 419: north portion of Room 142 above countertop and shelves. See Figure 10.	50	Yes	No	Remove drywall ceiling and ceiling tiles with excessive moisture.
Countertop with cabinets	Unit 419: north wall in Room 142. See Figure 11.	70	Yes	No	Remove countertop and cabinets.
Plaster wall	Unit 419: north wall in Room 142. See Figure 11.	70	Yes	No	Dry plaster wall.
Water-stained 1'x1' ceiling tiles	Unit 419: Room 154. See Figure 10.	9	No	No	Remove water-stained ceiling tiles.
Water-stained 1'x1' ceiling tiles	Unit 419: Room 153. See Figure 10.	18	No	No	Remove water-stained ceiling tiles.
Drywall ceiling with 1'x1' ceiling tiles	Unit 419: northwest corner of Room 140. See Figure 10.	90	Yes	No	Remove drywall ceiling and ceiling tiles with excessive moisture.
Drywall ceiling with 1'x1' ceiling tiles	Unit 419: northwest corner of Room 139. See Figure 10.	40	Yes	No	Remove drywall ceiling and ceiling tiles with excessive moisture.

Drywall ceiling with 1'x1' ceiling tiles	Unit 419: west portion of Room 151. See Figure 10.	30	Yes	No	Remove drywall ceiling and ceiling tiles with excessive moisture.
Light fixtures filled with water	Unit 419: Rooms 135, 149, and 153. See Figure 10.	3 fixtures	Not Applicable	No	Drain water and dispose of light fixtures.
Plaster wall	Unit 419: north wall in Room 132. See Figure 11.	60	Yes	No	Dry plaster wall.
Drywall ceiling with 1'x1' ceiling tiles (water-stained)	Unit 419: Room 132. See Figure 10.	24	Yes	No	Remove drywall ceiling.

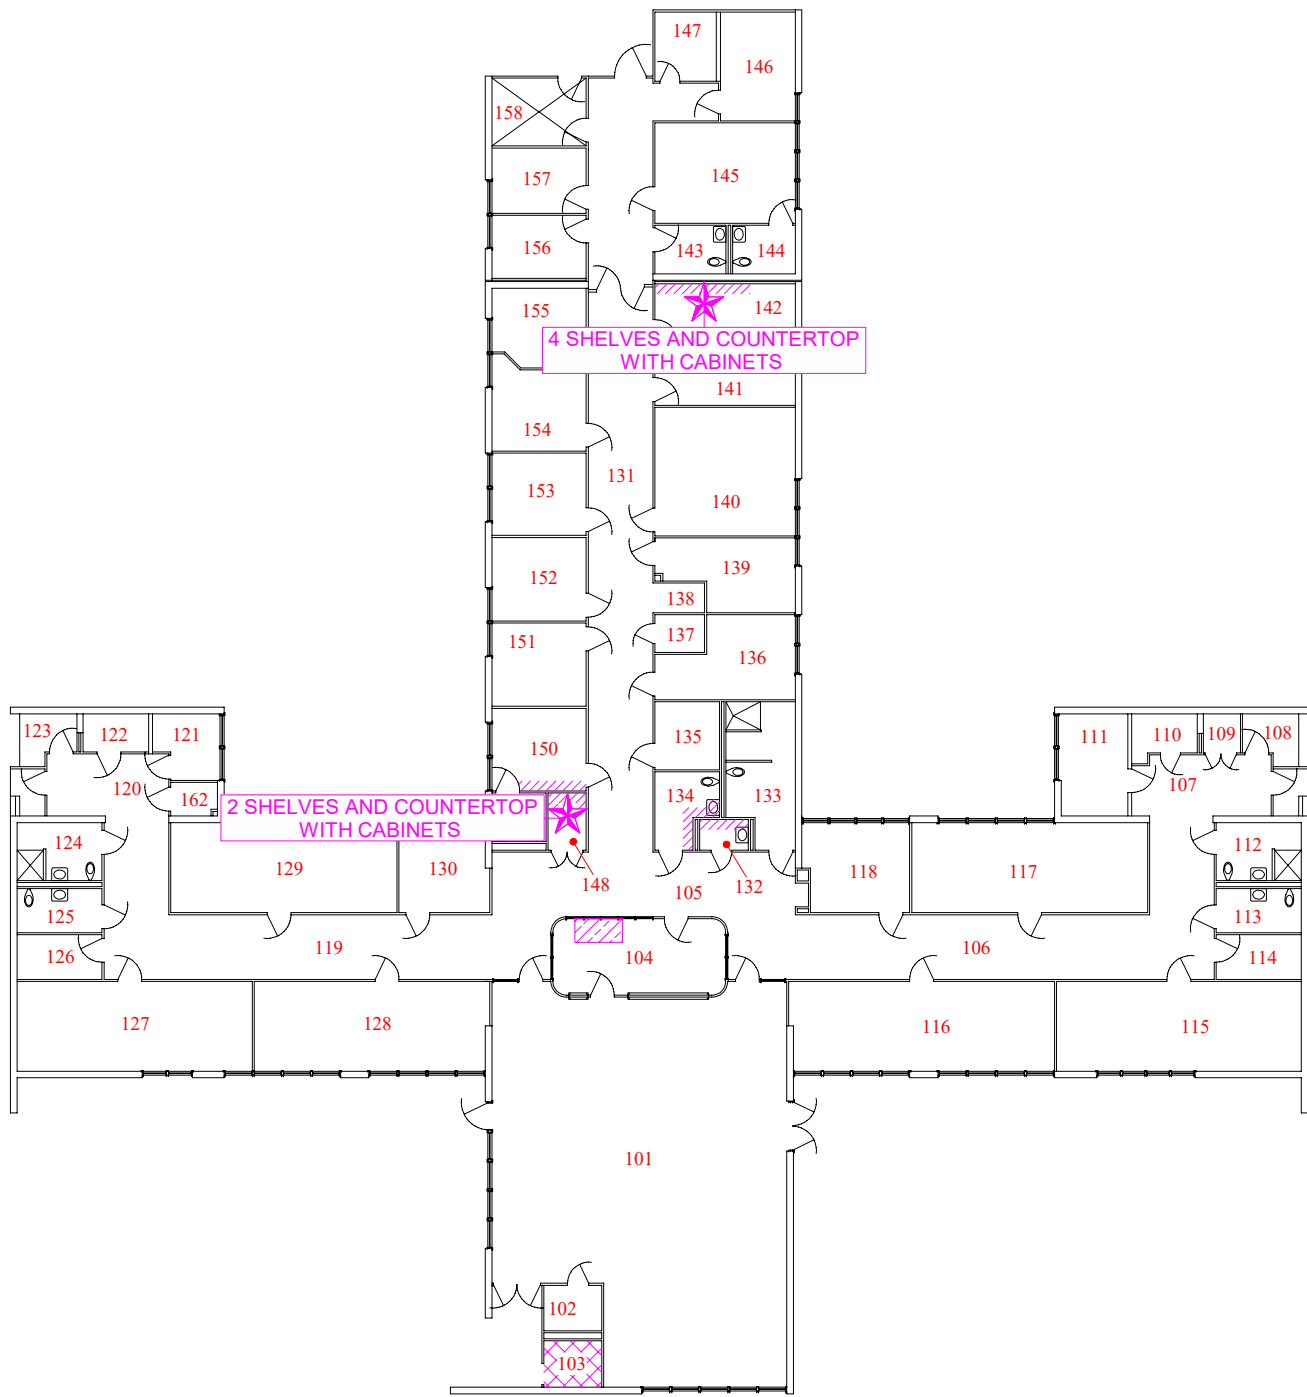
WATER DAMAGED MATERIALS/COMPONENTS
 SNF BUILDING
 UNIT 419 - WALL PLAN
 11401 BLOOMFIELD AVENUE
 NORWALK, CALIFORNIA

MATERIAL/COMPONENT	LOCATION	WATER DAMAGE (SF)	EXCESSIVE MOISTURE	MOLD PRESENT	RECOMMENDATION
Plaster walls with bubbling paint	Unit 419: three walls on southeast corner of Room 134. Excessive moisture in the plaster begins at the sink and continues to the two walls south of sink and ends at doorway. See Figure 11.	100	Yes	No	Remove bubbling paint. Dry plaster walls.
Countertop with cabinets	Unit 419: a section of countertop and cabinets on the northwest portion of Room 104. See Figure 11.	20	Yes	No	Remove countertop and cabinets.
Plaster ceiling with water-staining	Unit 419: central portion of Room 149. See Figure 10.	20	Yes	No	Dry plaster ceiling and apply new coat of paint to cover water-staining.
Plaster wall with bubbling paint	Unit 419: south wall in Room 150. See Figure 11.	40	Yes	No	Remove bubbling paint. Dry plaster wall.
Plaster walls	Unit 419: plaster walls on three (3) sides of sink on the north portion of Room 148. See Figure 11.	130	Yes	No	Dry plaster walls.

Shelves	Unit 419: north wall in Room 148. See Figure 11.	2 shelves	Yes	No	Remove shelves.
Countertop with cabinets	Unit 419: north wall in Room 148. See Figure 11.	10	Yes	No	Remove countertop and cabinets
Water-stained 1'x1' ceiling tiles	Unit 420: Room 110. See Figure 12.	1	No	No	Remove water-stained ceiling tile.
Water-stained 1'x1' ceiling tiles	Unit 420: Room 122. See Figure 12.	24	No	No	Remove water-stained ceiling tiles.
Plaster ceiling	Unit 420: one location on east portion of Room 104. See Figure 12.	10	Yes	No	Dry plaster ceiling.
Plaster wall with bubbling paint	Unit 420: under the far east window on south wall of Room 101. See Figure 13.	30	Yes	No	Remove bubbling paint. Dry plaster wall.
Bubbling paint on concrete wall	Unit 420: southeast corner of Room 143 on south wall. See Figure 13.	5	No	No	Remove bubbling paint on concrete wall.

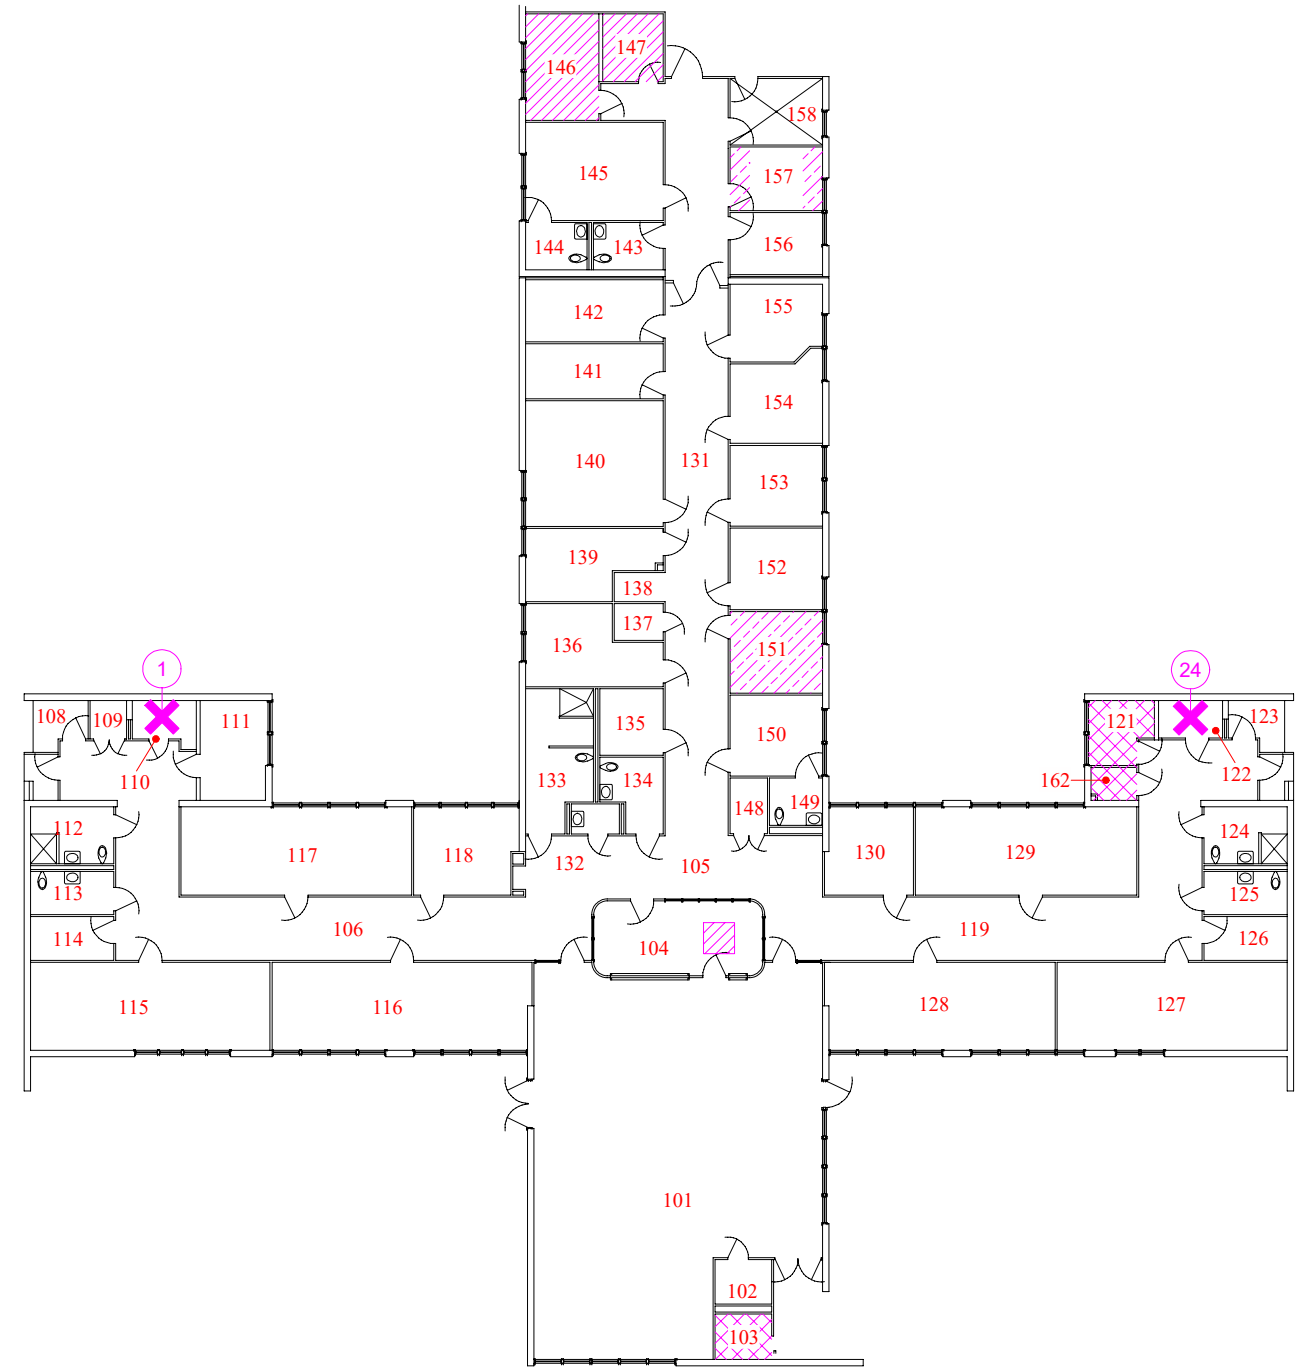
WATER DAMAGED MATERIALS/COMPONENTS
 SNF BUILDING
 UNIT 420 - CEILING PLAN
 11401 BLOOMFIELD AVENUE
 NORWALK, CALIFORNIA

MATERIAL/COMPONENT	LOCATION	WATER DAMAGE (SF)	EXCESSIVE MOISTURE	MOLD PRESENT	RECOMMENDATION
Drywall ceiling with 1'x1' ceiling tiles	Unit 420: Room 151. See Figure 12.	130	Yes	No	Remove drywall ceiling.
Plaster ceiling with bubbling paint	Unit 420: Room 146. See Figure 12.	130	Yes	No	Remove bubbling paint. Dry plaster ceiling.
Plaster ceiling	Unit 420: Room 147. See Figure 12.	70	Yes	No	Dry plaster ceiling.
Drywall ceiling with 1'x1' ceiling tiles	Unit 420: two locations in Room 157. One location is on the west portion of room and second location is on the east portion of room. See Figure 12.	40	Yes	No	Remove drywall ceiling and ceiling tiles with excessive moisture.
Plaster wall	Unit 420: under the window on east wall in Room 157. See Figure 13.	20	Yes	No	Dry plaster wall.
Plaster wall with bubbling paint and water-staining	Unit 420: east wall in Room 156. See Figure 13.	40	Yes	No	Remove bubbling paint. Dry plaster wall.

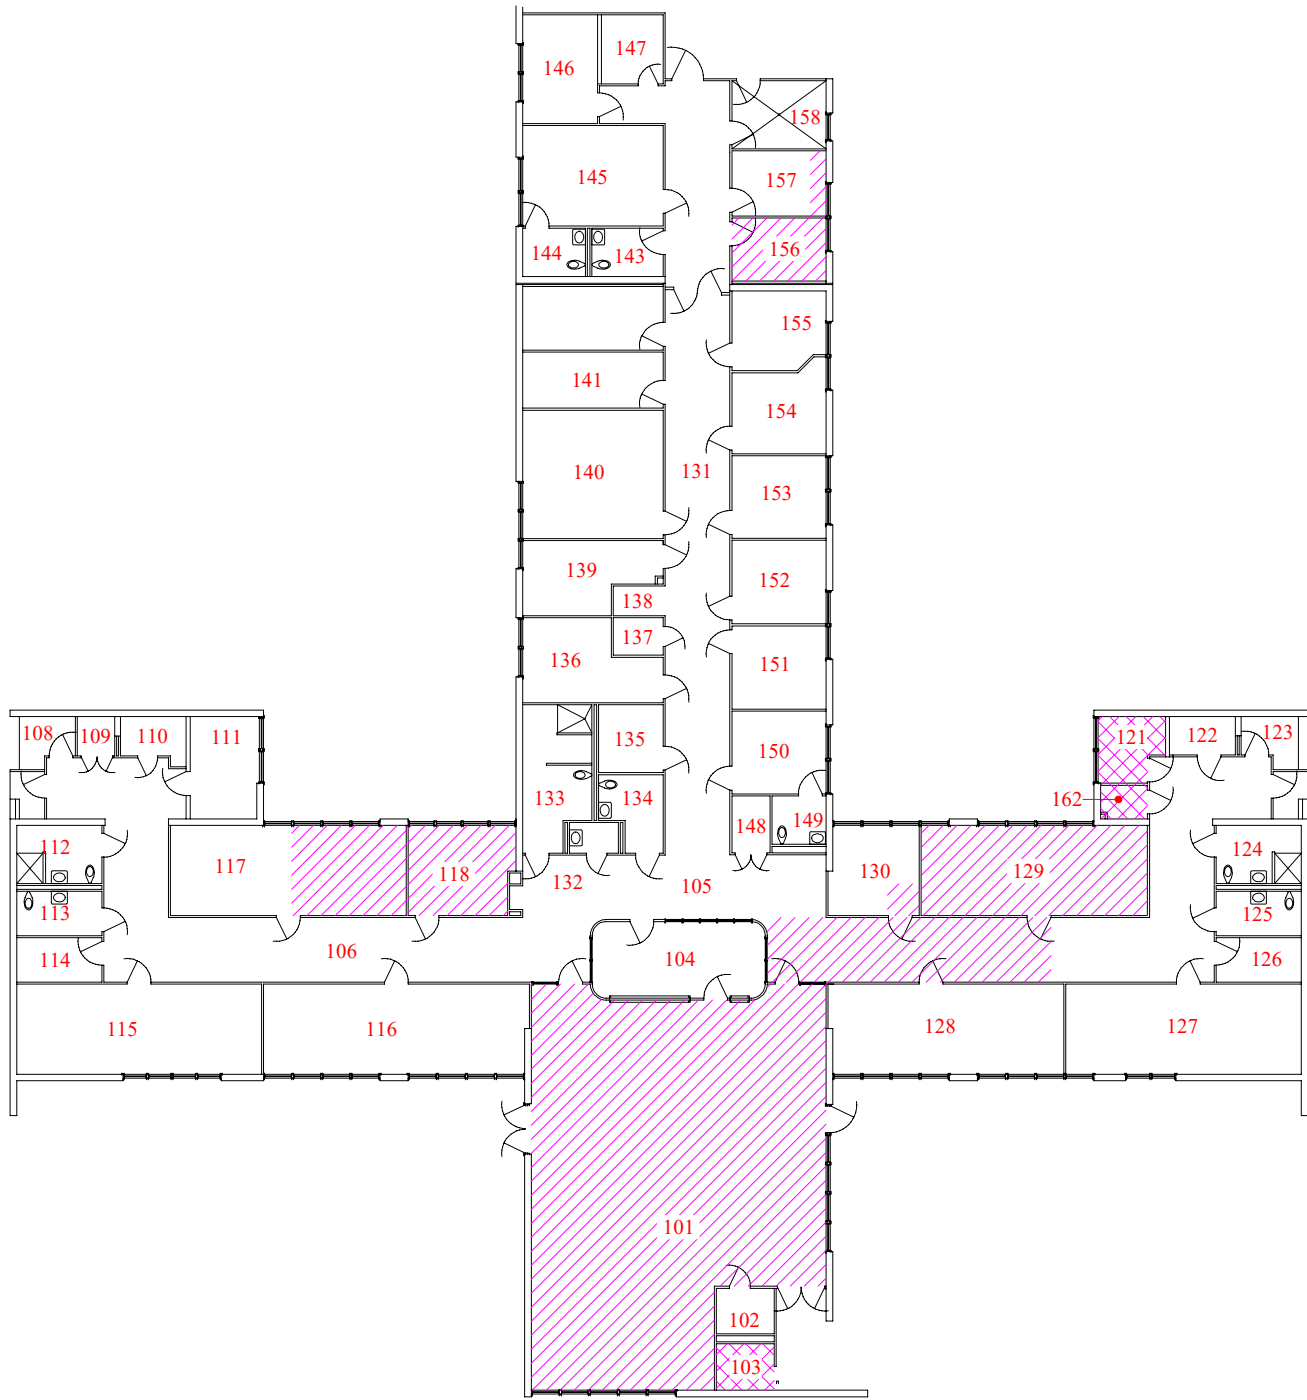
WATER DAMAGED MATERIALS/COMPONENTS
 SNF BUILDING
 UNIT 420 - FLOOR PLAN
 11401 BLOOMFIELD AVENUE
 NORWALK, CALIFORNIA

MATERIAL/COMPONENT	LOCATION	WATER DAMAGE (SF)	EXCESSIVE MOISTURE	MOLD PRESENT	RECOMMENDATION
Lifting floor tiles, 1'x1', brown with dark brown specks	Unit 420: east portion of Room 117 (lifting floor tiles start after the first window on north wall). See Figure 14.	170	Not Applicable	No	Remove lifting floor tiles and black mastic. The black mastic contains >1% asbestos.
Lifting floor tiles, 1'x1', brown with dark brown specks	Unit 420: hallway east of Room 104. Lifting floor tiles end after the door leading to Room 129. See Figure 14.	300	Not Applicable	No	Remove lifting floor tiles and black mastic. The black mastic contains >1% asbestos.
Lifting floor tiles, 1'x1', brown with dark brown specks	Unit 420: Room 101. See Figure 14.	1,700	Not Applicable	No	Remove all floor tiles and black mastic. The black mastic contains >1% asbestos.
Fiberglass insulation on ducts and pipes	Throughout this building.	Unknown	Yes	No	Dry the fiberglass insulation on ducts and pipes.
