FINAL WATER INTRUSION ASSESSMENT AND ASBESTOS SURVEY

DSH METROPOLITAN SNF BLDG REPAIR PROJECT

DEPARTMENT OF STATE HOSPITALS

May 2022

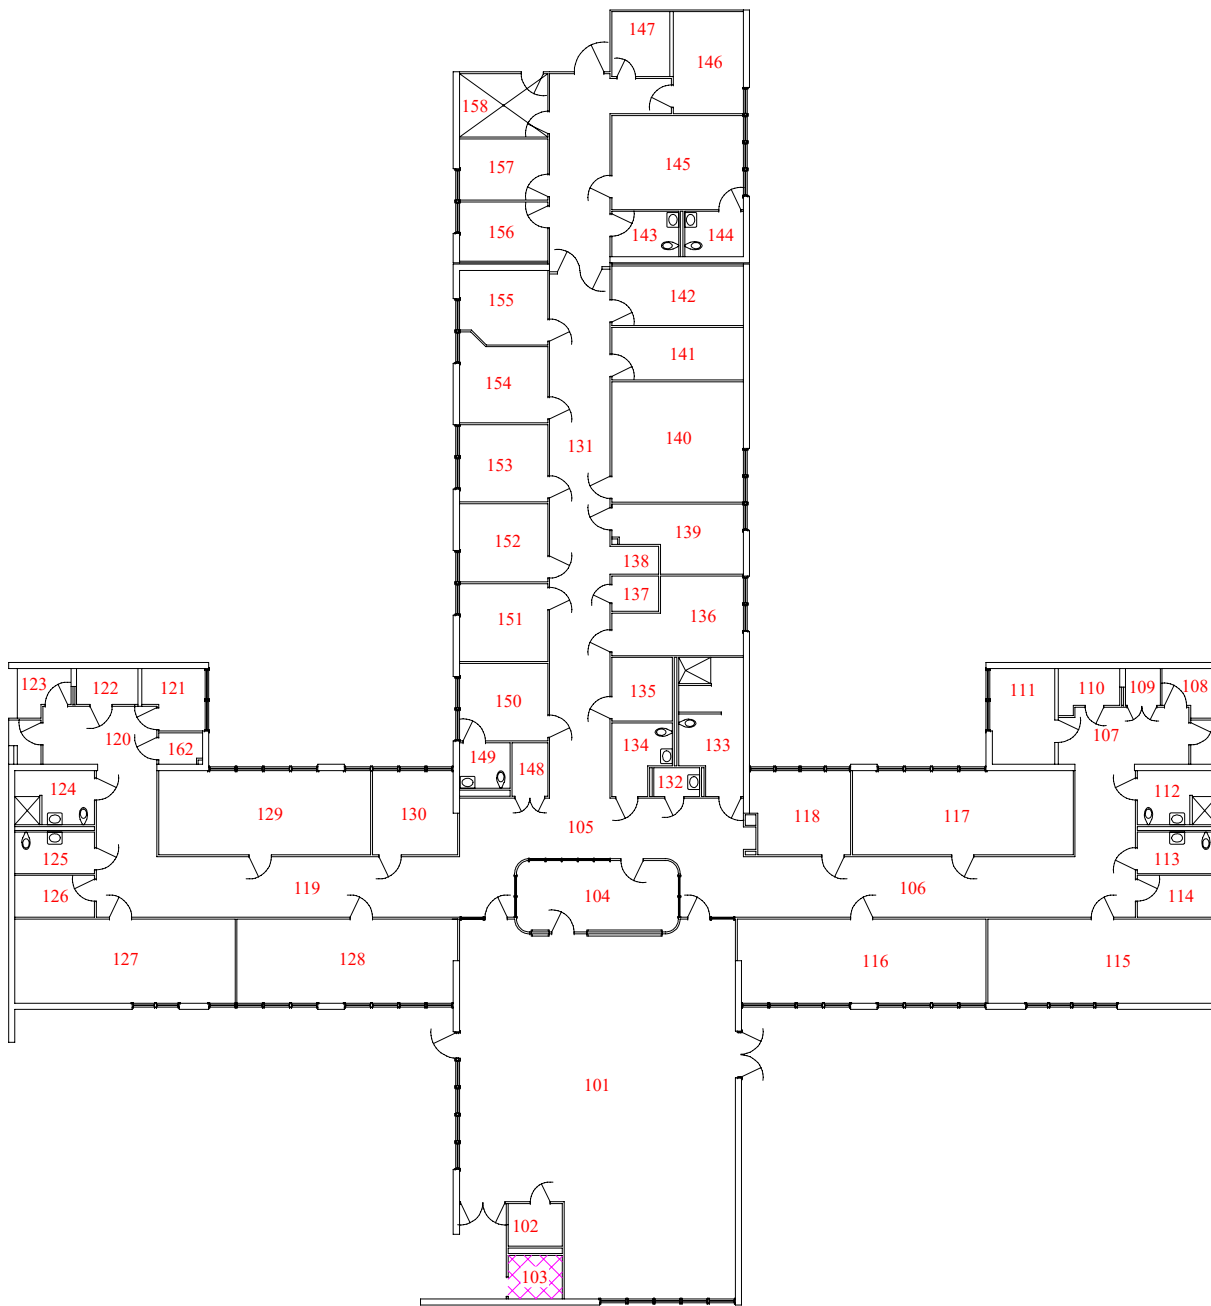
BULK SAMPLE LOCATIONS
 SNF BUILDING
 UNIT 418 - FLOOR PLAN
 11401 BLOOMFIELD AVENUE
 NORWALK, CALIFORNIA

LIFTING FLOOR TILES WERE NOT OBSERVED IN THIS UNIT

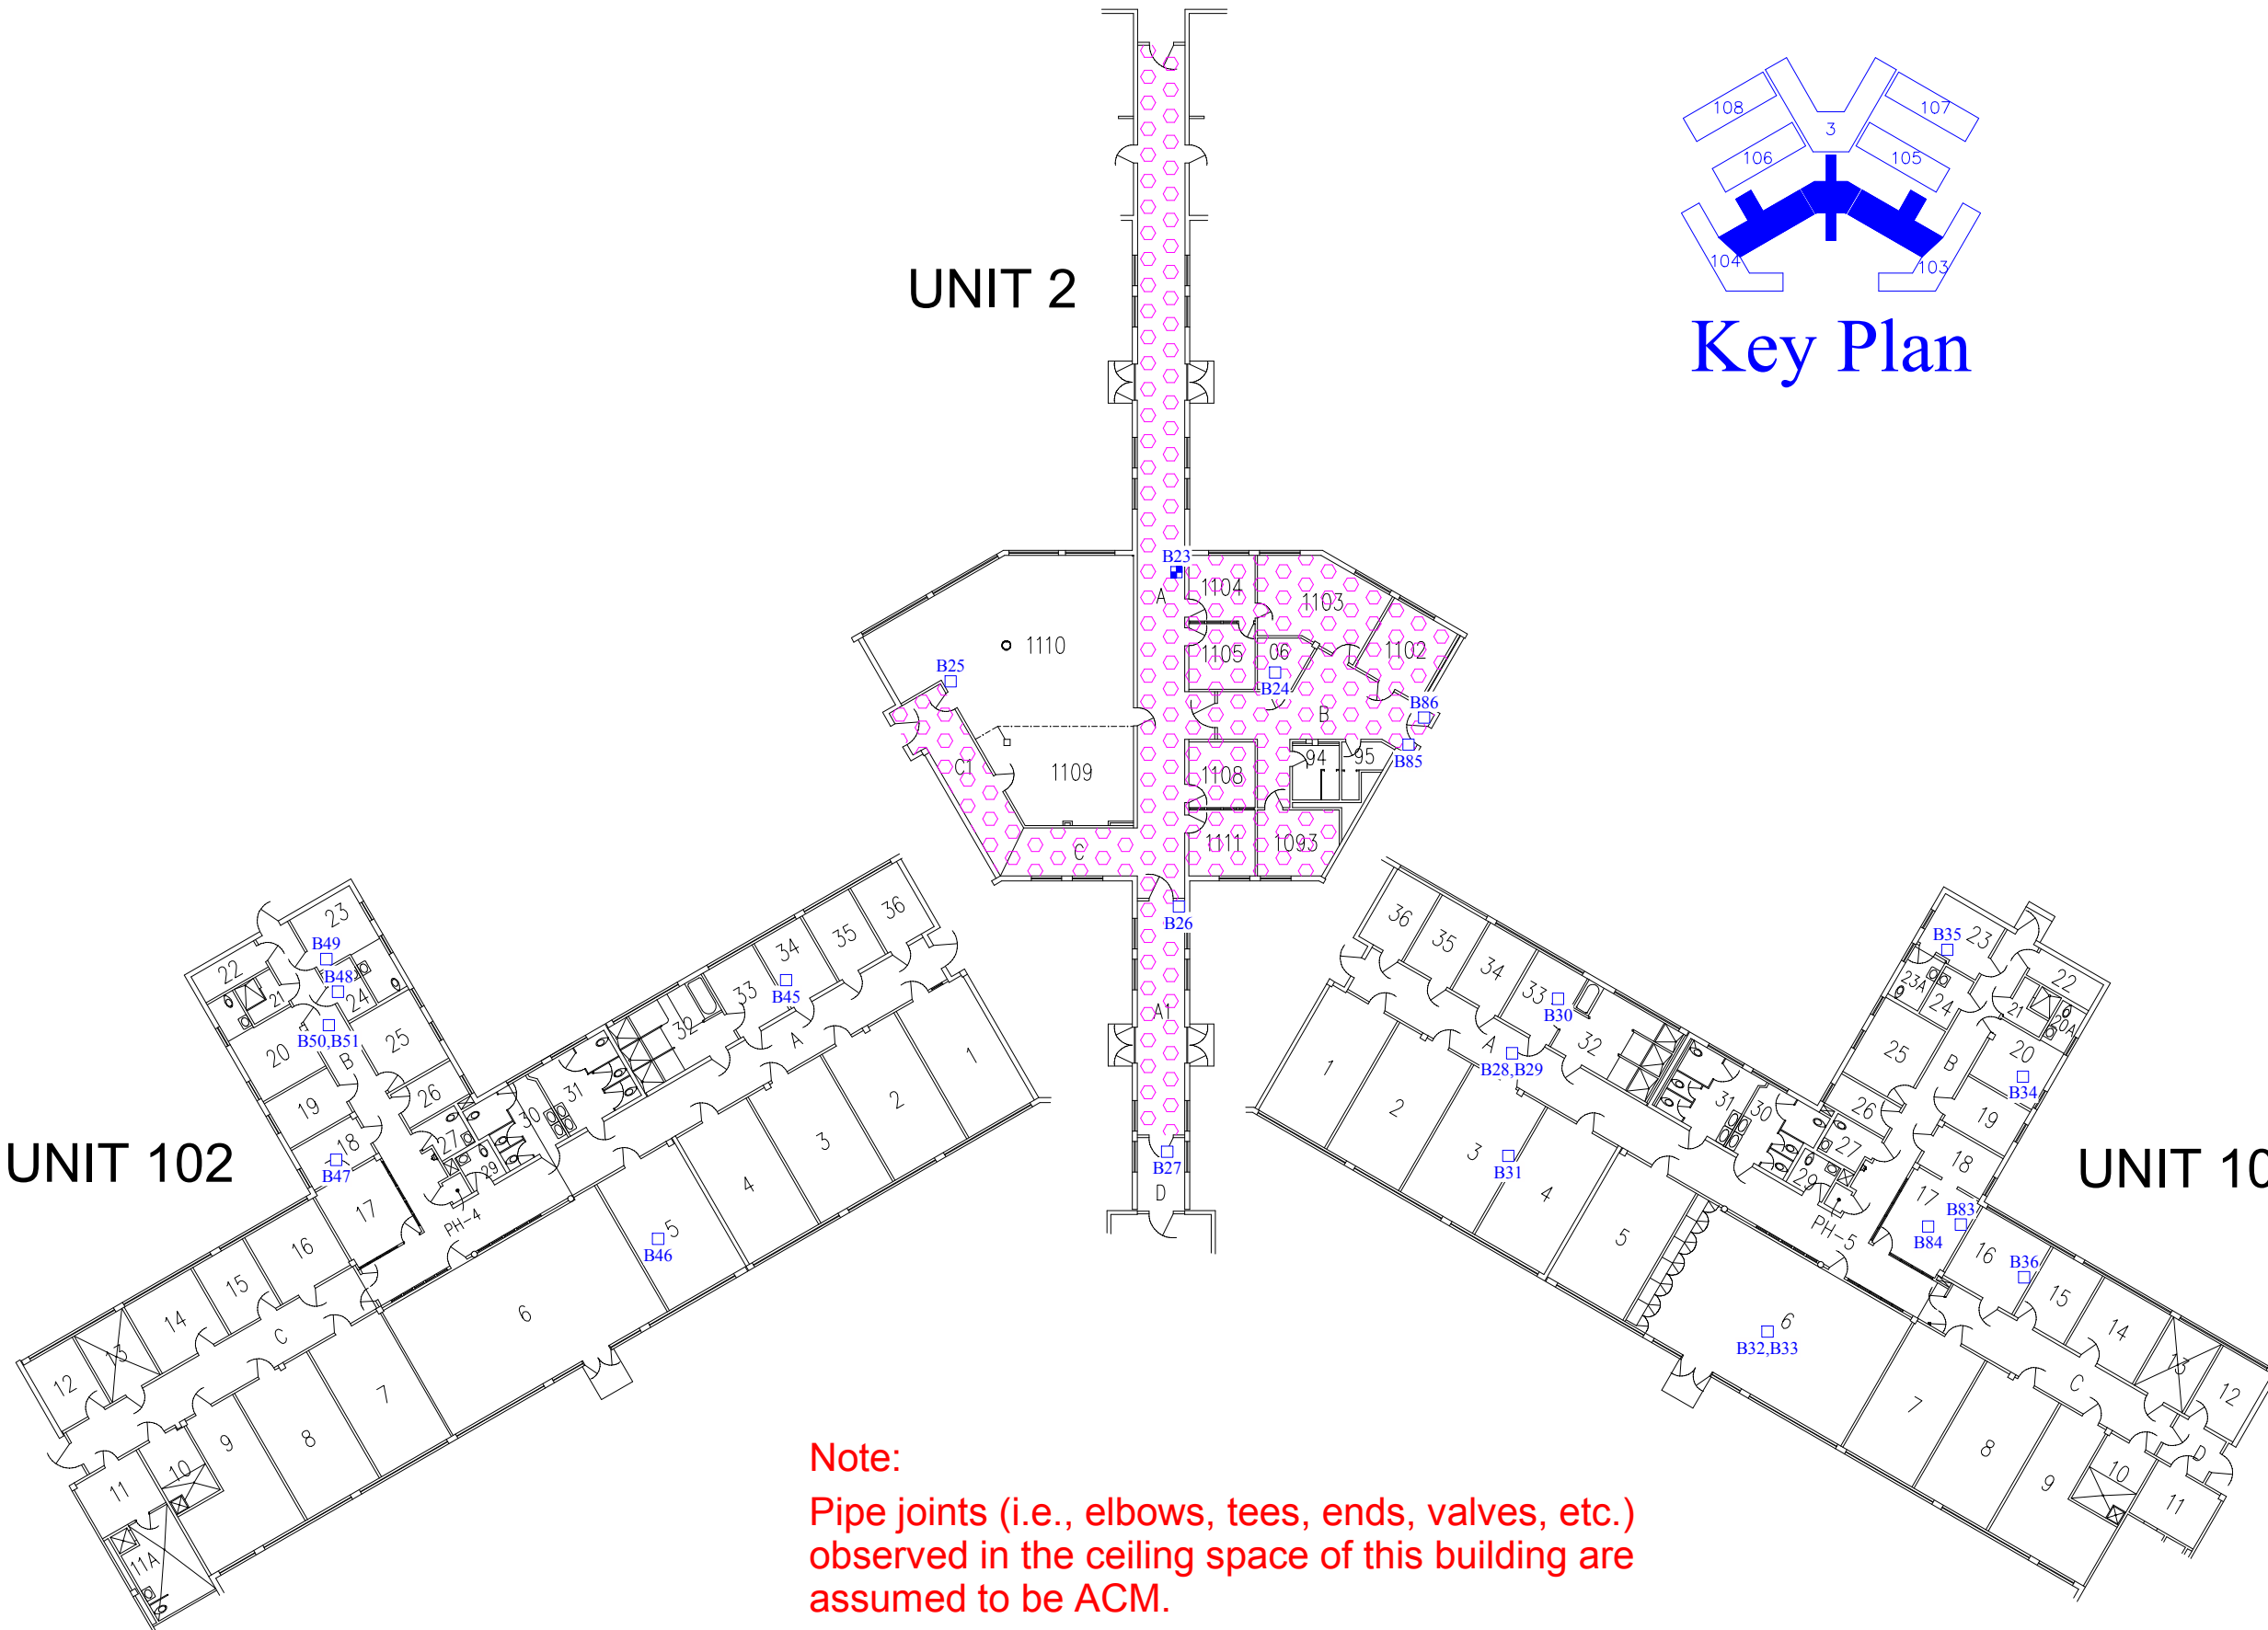
Note:
 Pipe joints (i.e., elbows, tees, ends, valves, etc.) observed in the ceiling space of this building are assumed to be ACM.

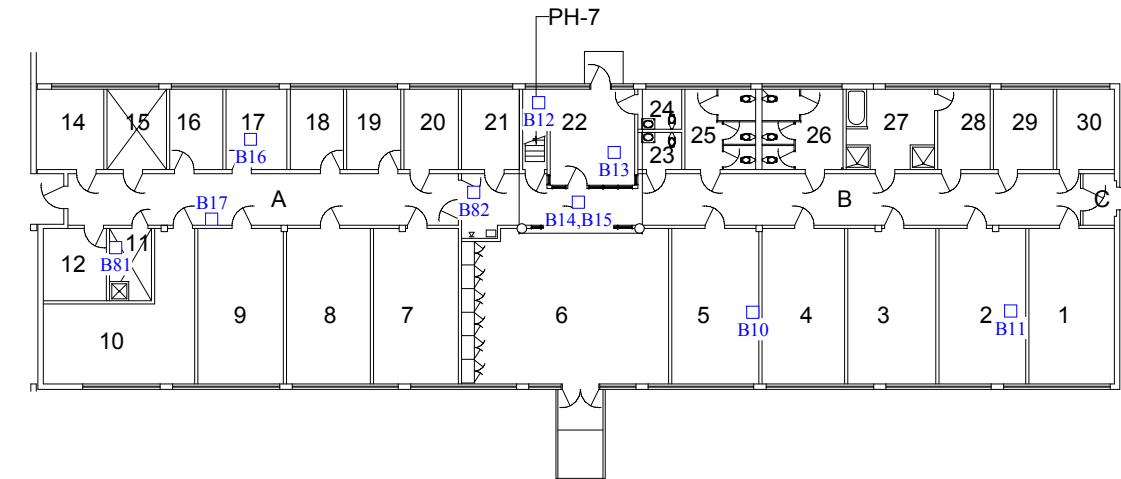
UNIT 105

Note:
Pipe joints (i.e., elbows, tees, ends, valves, etc.)
observed in the ceiling space of this building are
assumed to be ACM.

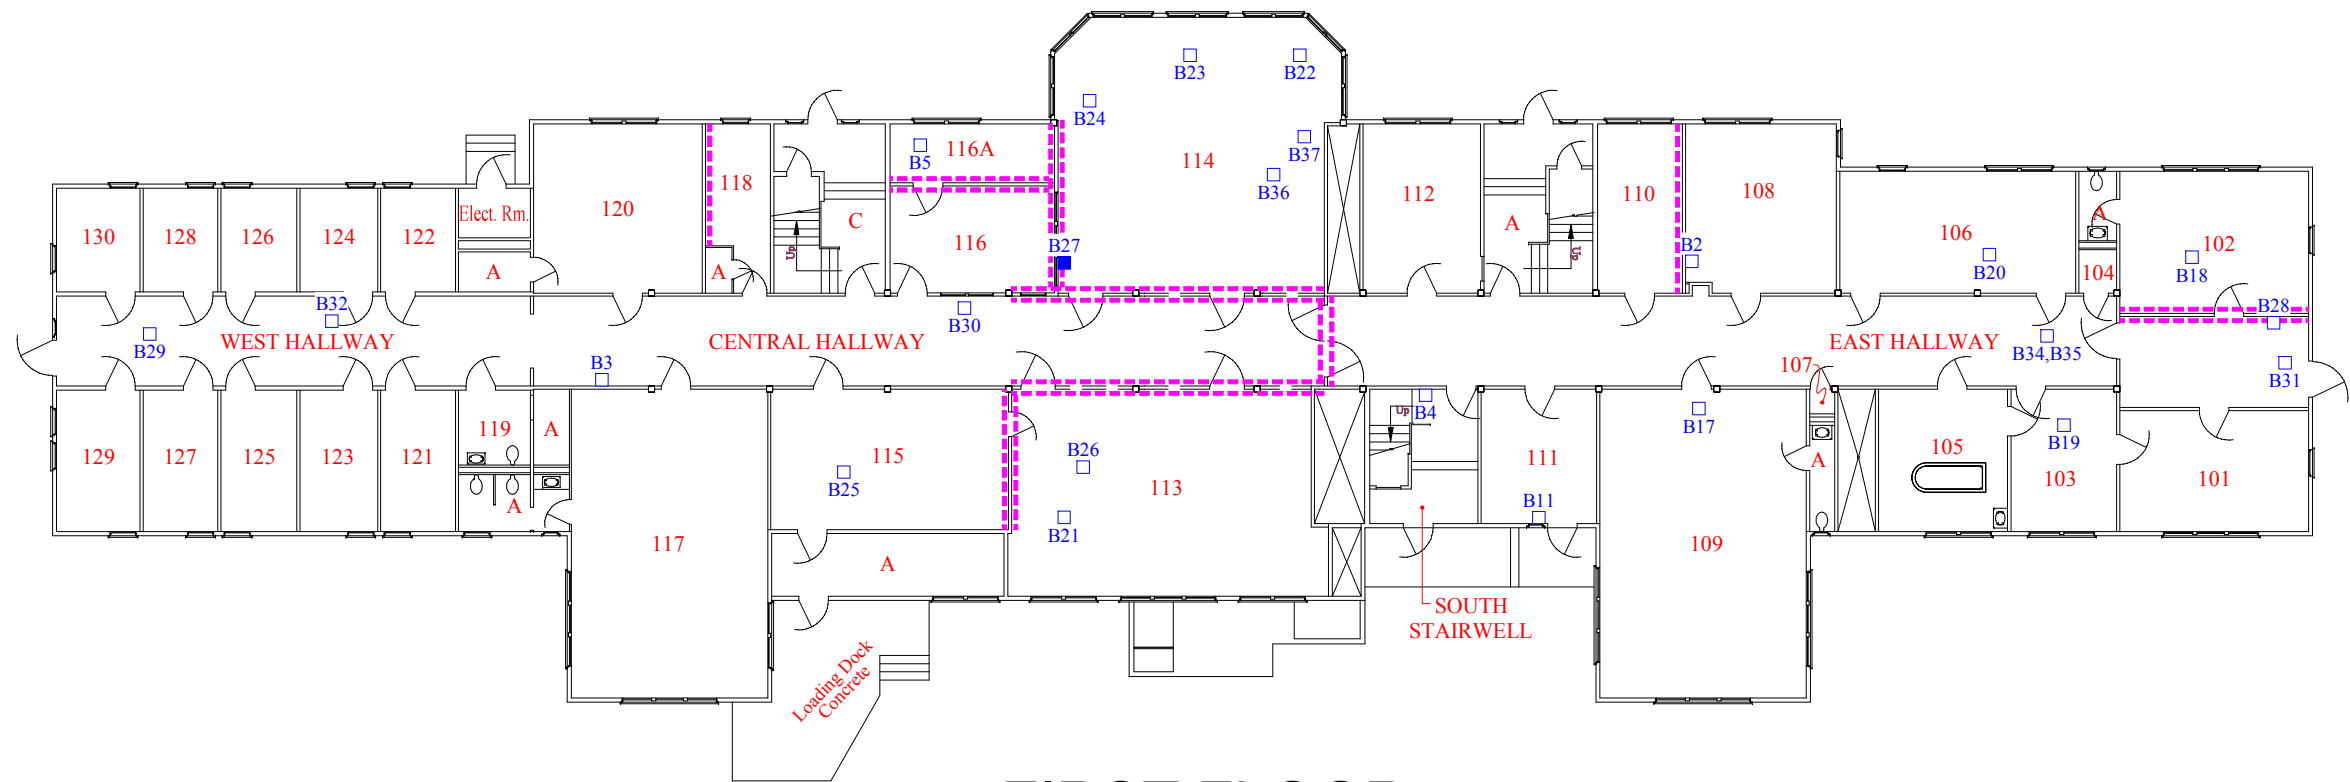
FIRST FLOOR

Wall System With Asbestos-Containing Joint Compound (>1% Asbestos). As A Composite System, It Is Assumed to Contain <1% Asbestos.

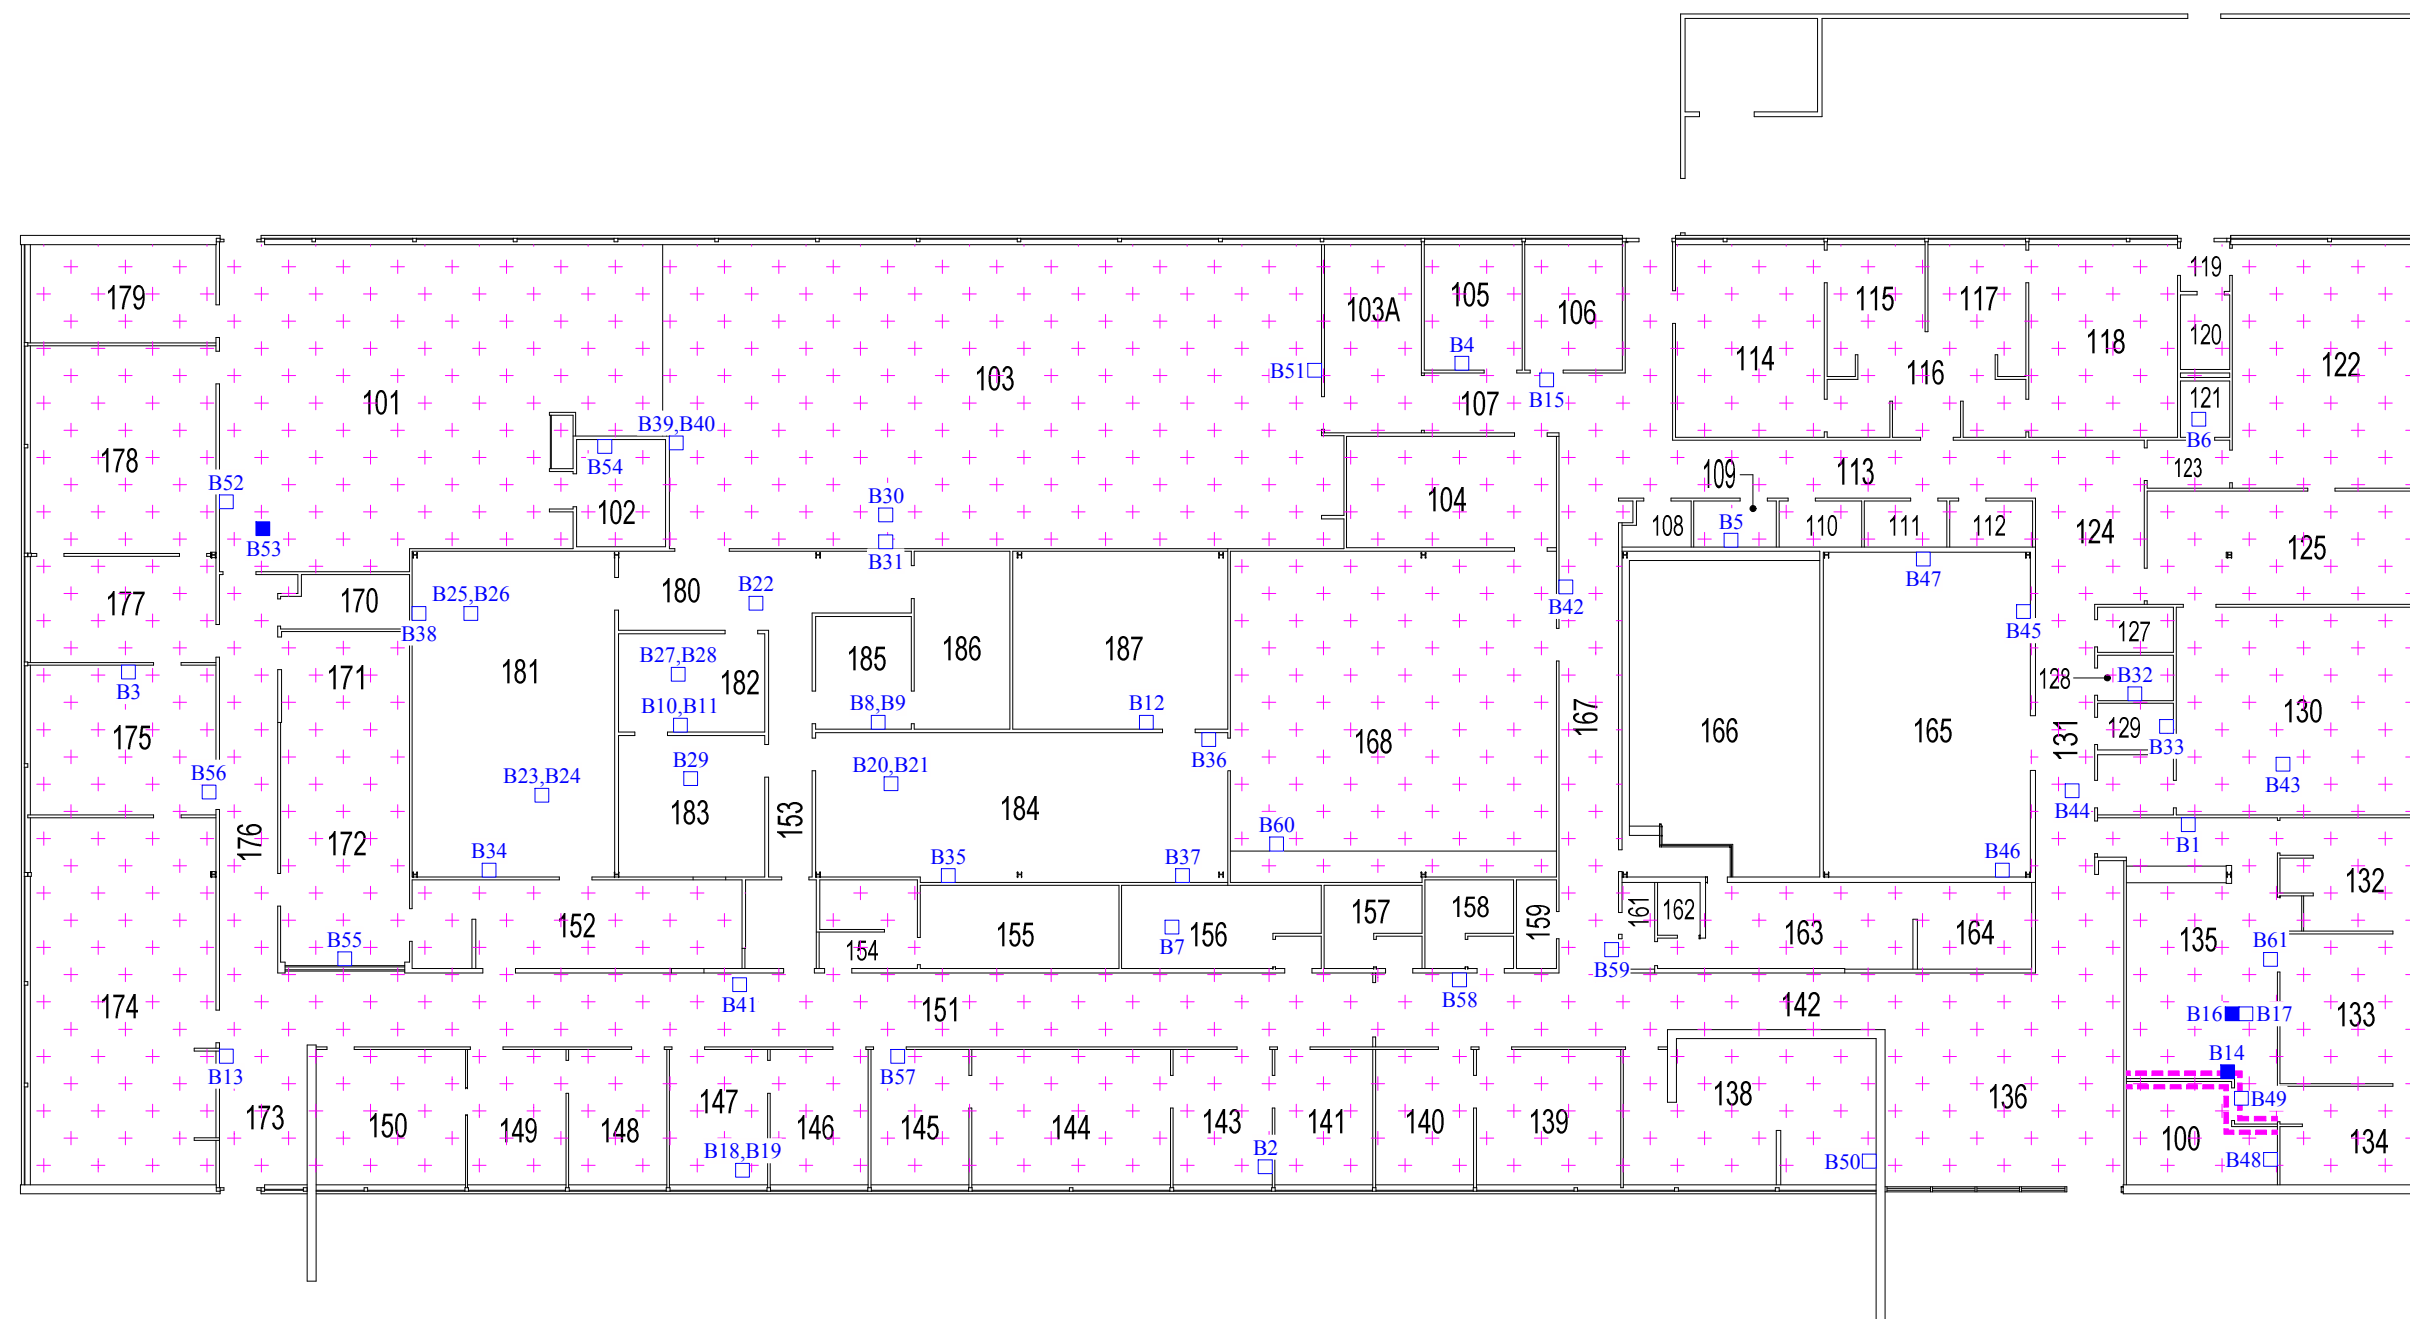
Ceiling System With Asbestos-Containing Joint Compound (>1% Asbestos). As A Composite System, It Is Assumed to Contain <1% Asbestos.
